Support Services for the Automotive Gas Turbine Project

Summary Report

Edited by
T. Golec
Chrysler Corporation
Detroit, Michigan 48288

April, 1981

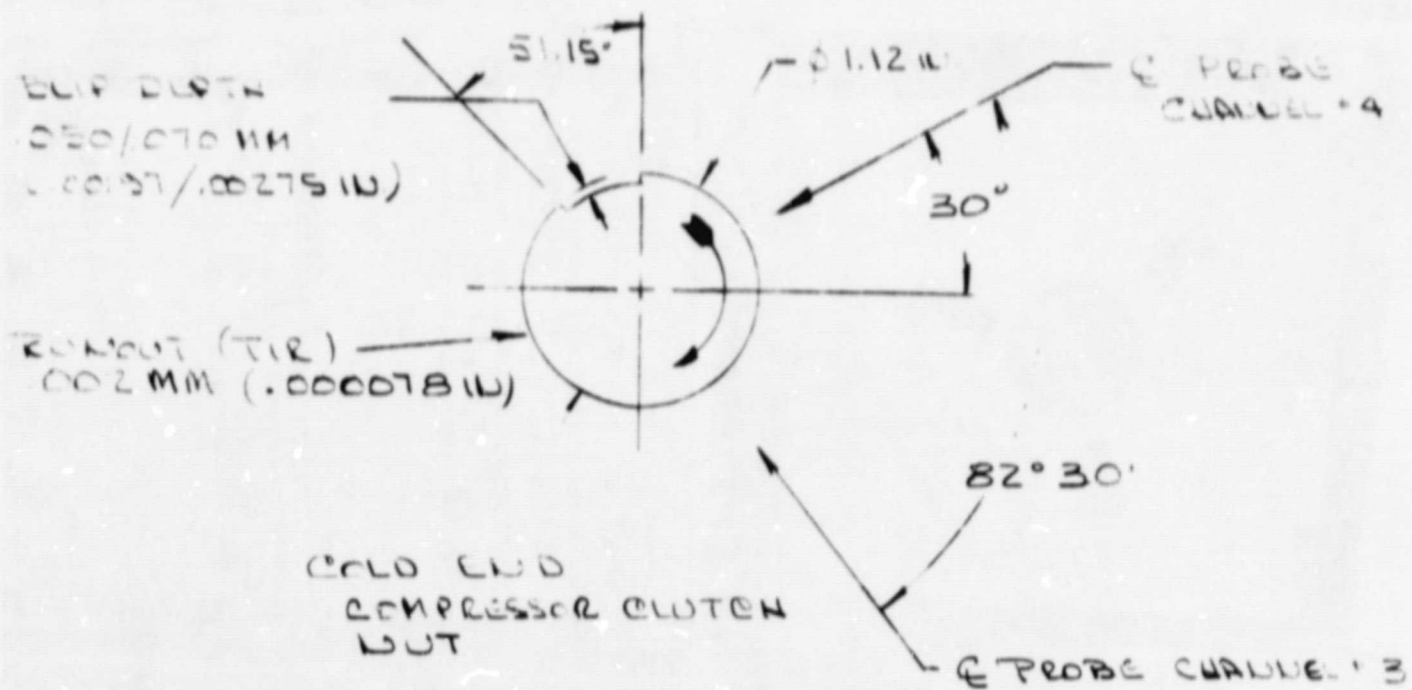
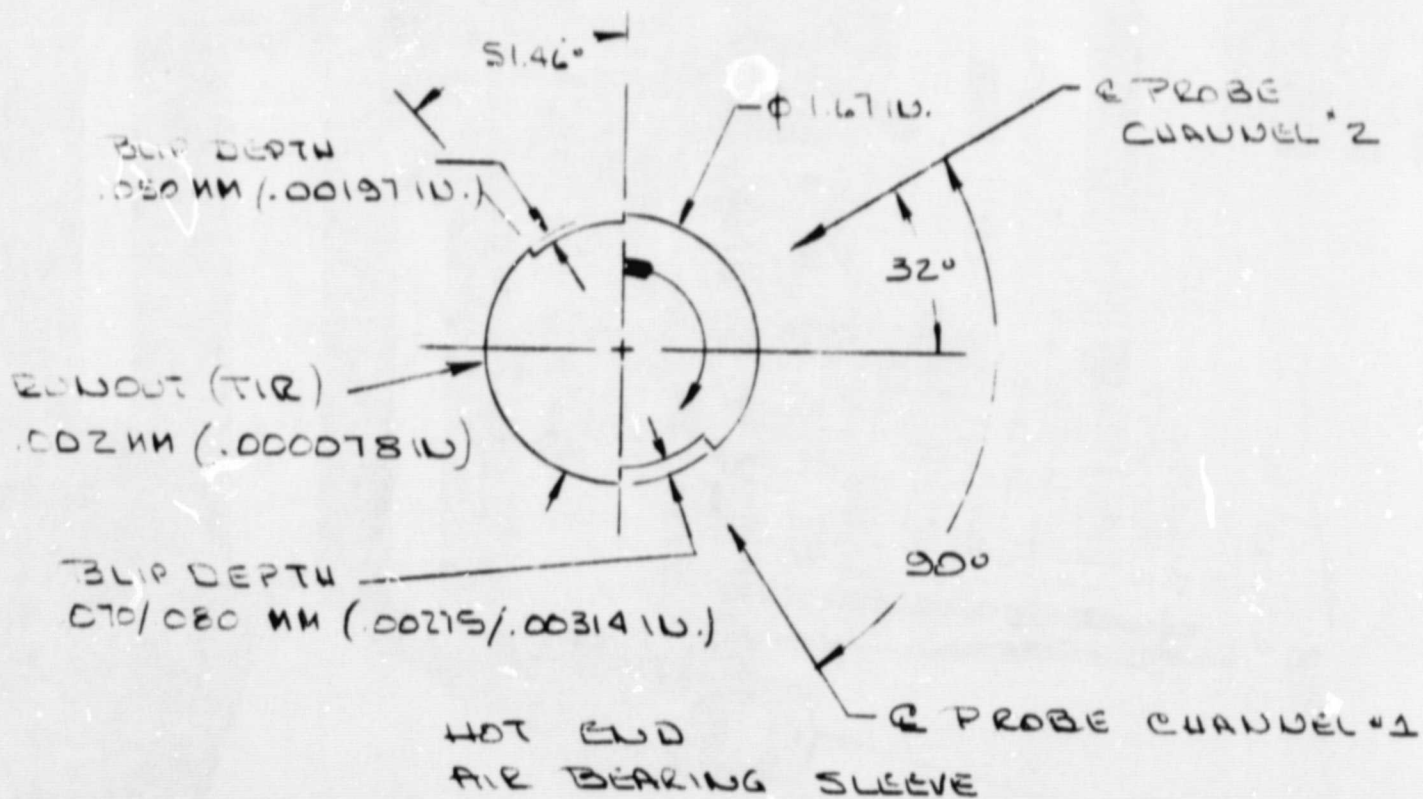
FIGURE 3

The gas generator was instrumented with two pair of probes, front and rear, as shown in Figure 2, to define shaft movements. It was not feasible to calibrate the probe system to determine the temperature effect on the output signal. Therefore, the surfaces beneath the probes were interrupted with grooves of two different depths (blips). These grooves act as calibration marks to determine both shaft deflection amplitudes and shaft orientation. The groove detail is shown in Figure 3.

Probe Orientation -- Shaft Dynamics

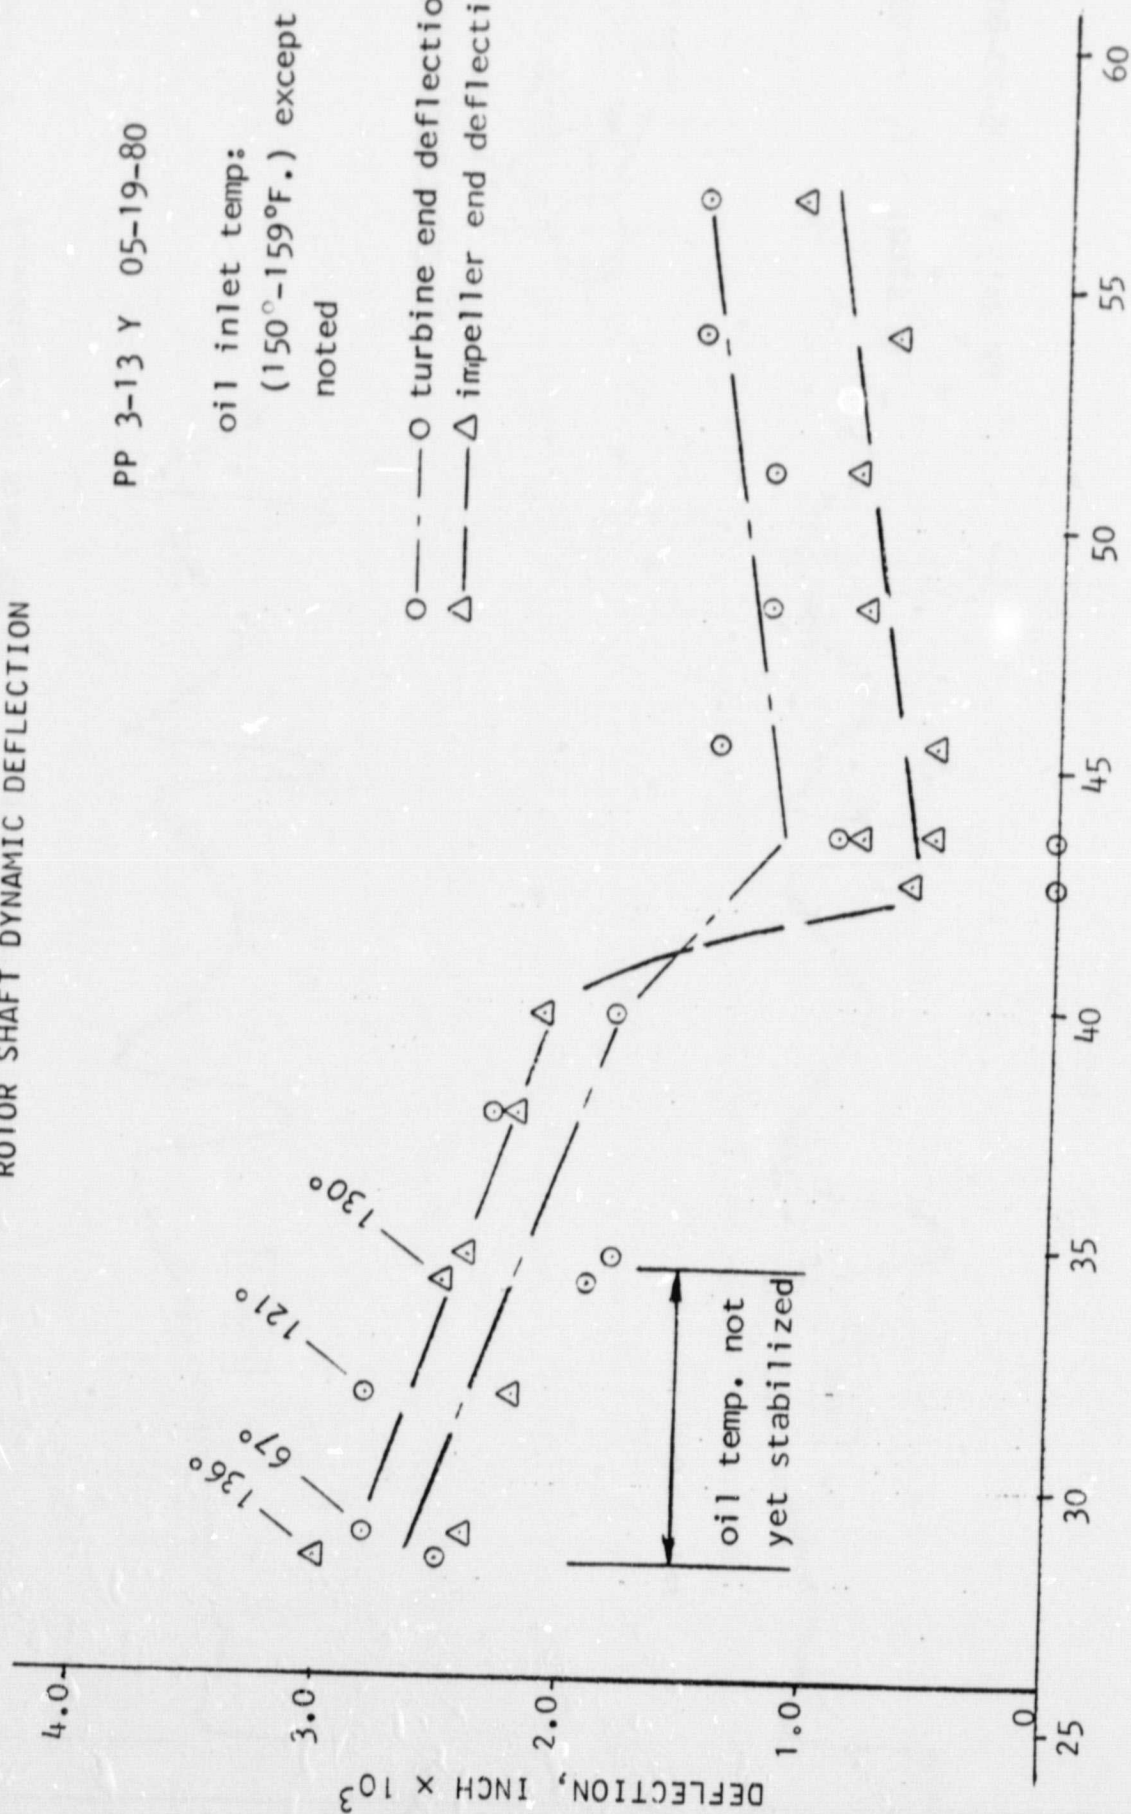
FIGURE 6

Figure 6 shows the deflection amplitudes for both the cold (front) and hot (rear) locations. These data are from initial tests before the FM tape recording outputs were available.

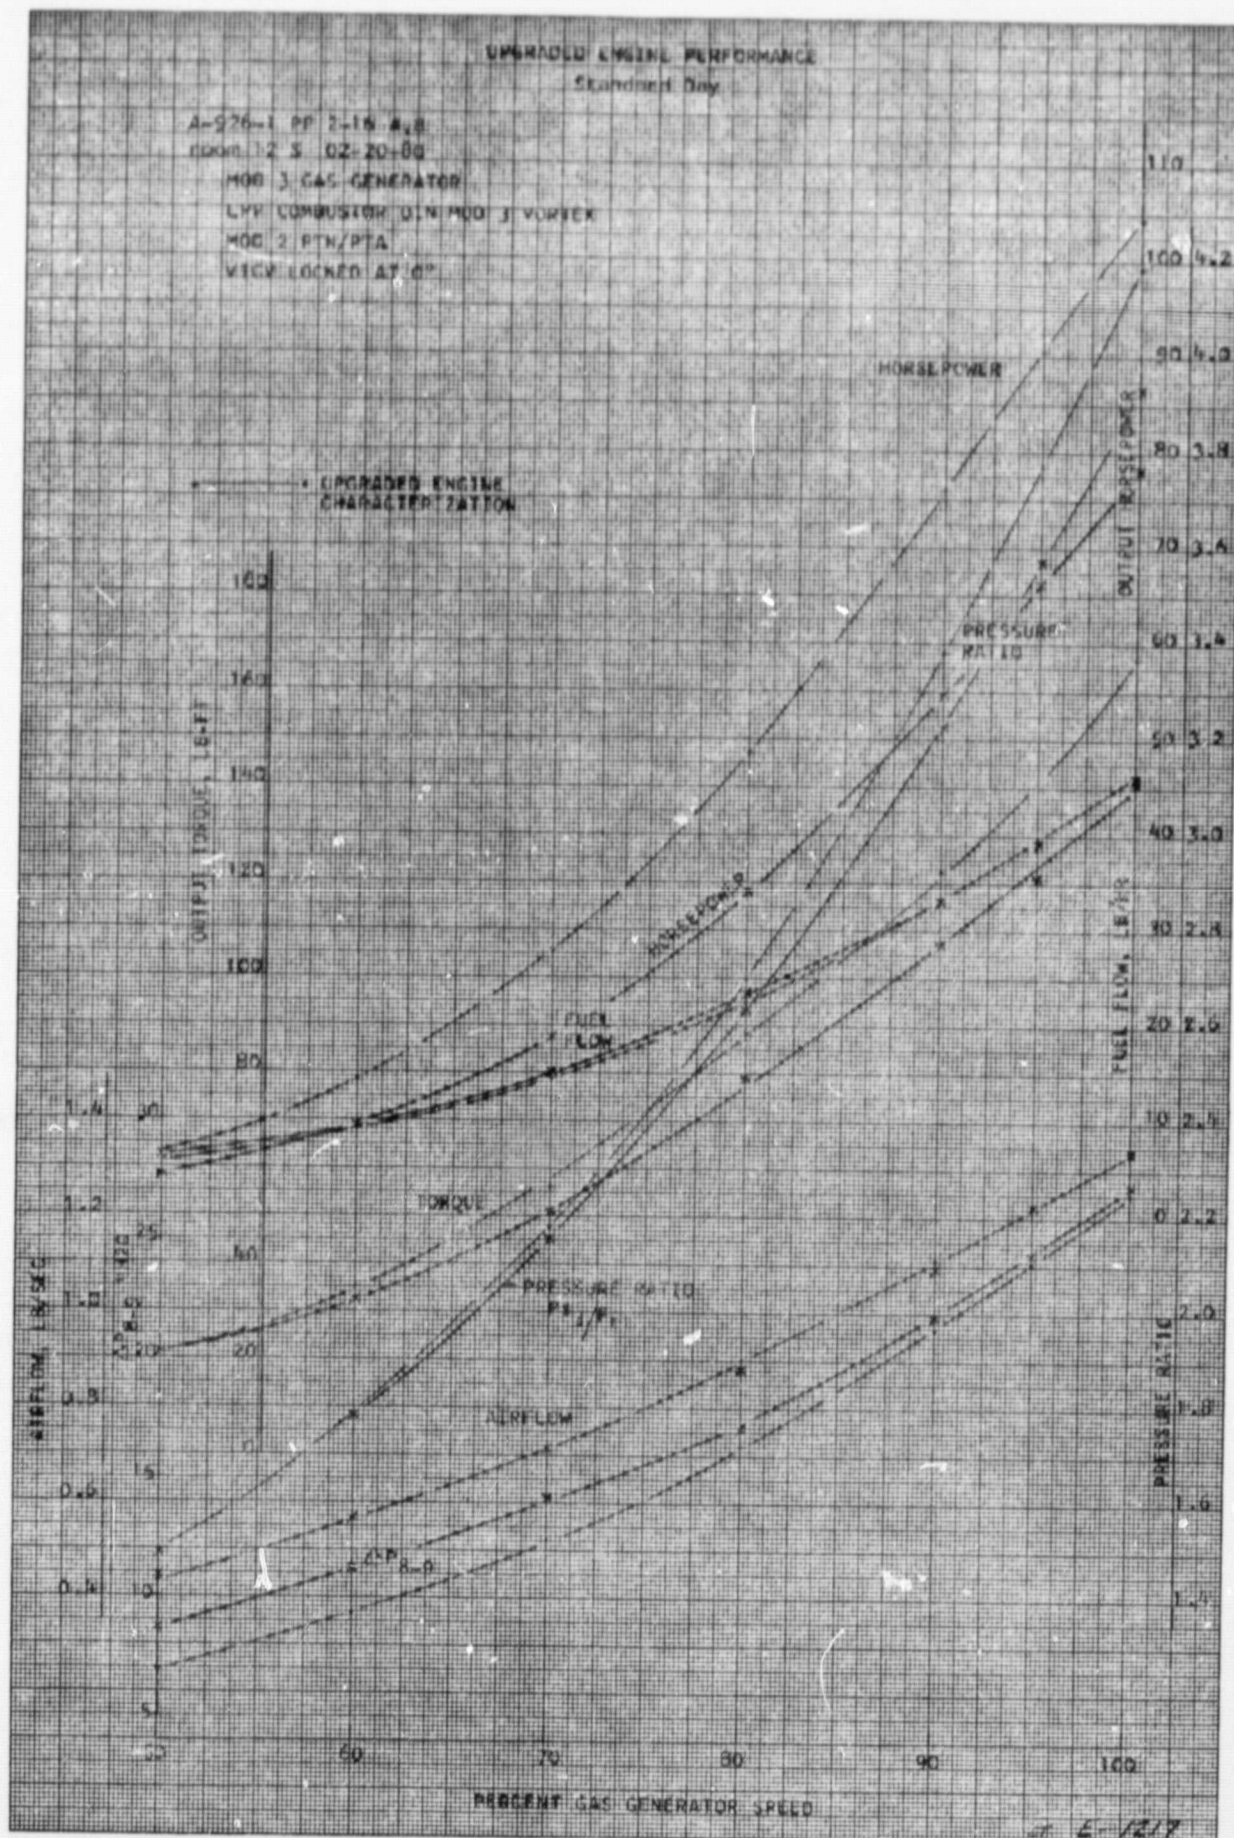
FIGURE 10

Shakedown testing revealed no mechanical problems, and performance was satisfactory at 79.3 HP. Figures 10 and 11 compare PP2-16's performance to the original A-926 design goals. The lower-than-expected performance was attributed to the high compressor clearances, salvaged PT wheel, and excessive seal leakage, as discussed above. However, it should be noted that, prior to retrofit, this engine only produced 53.6 HP (PP2-3 BK).

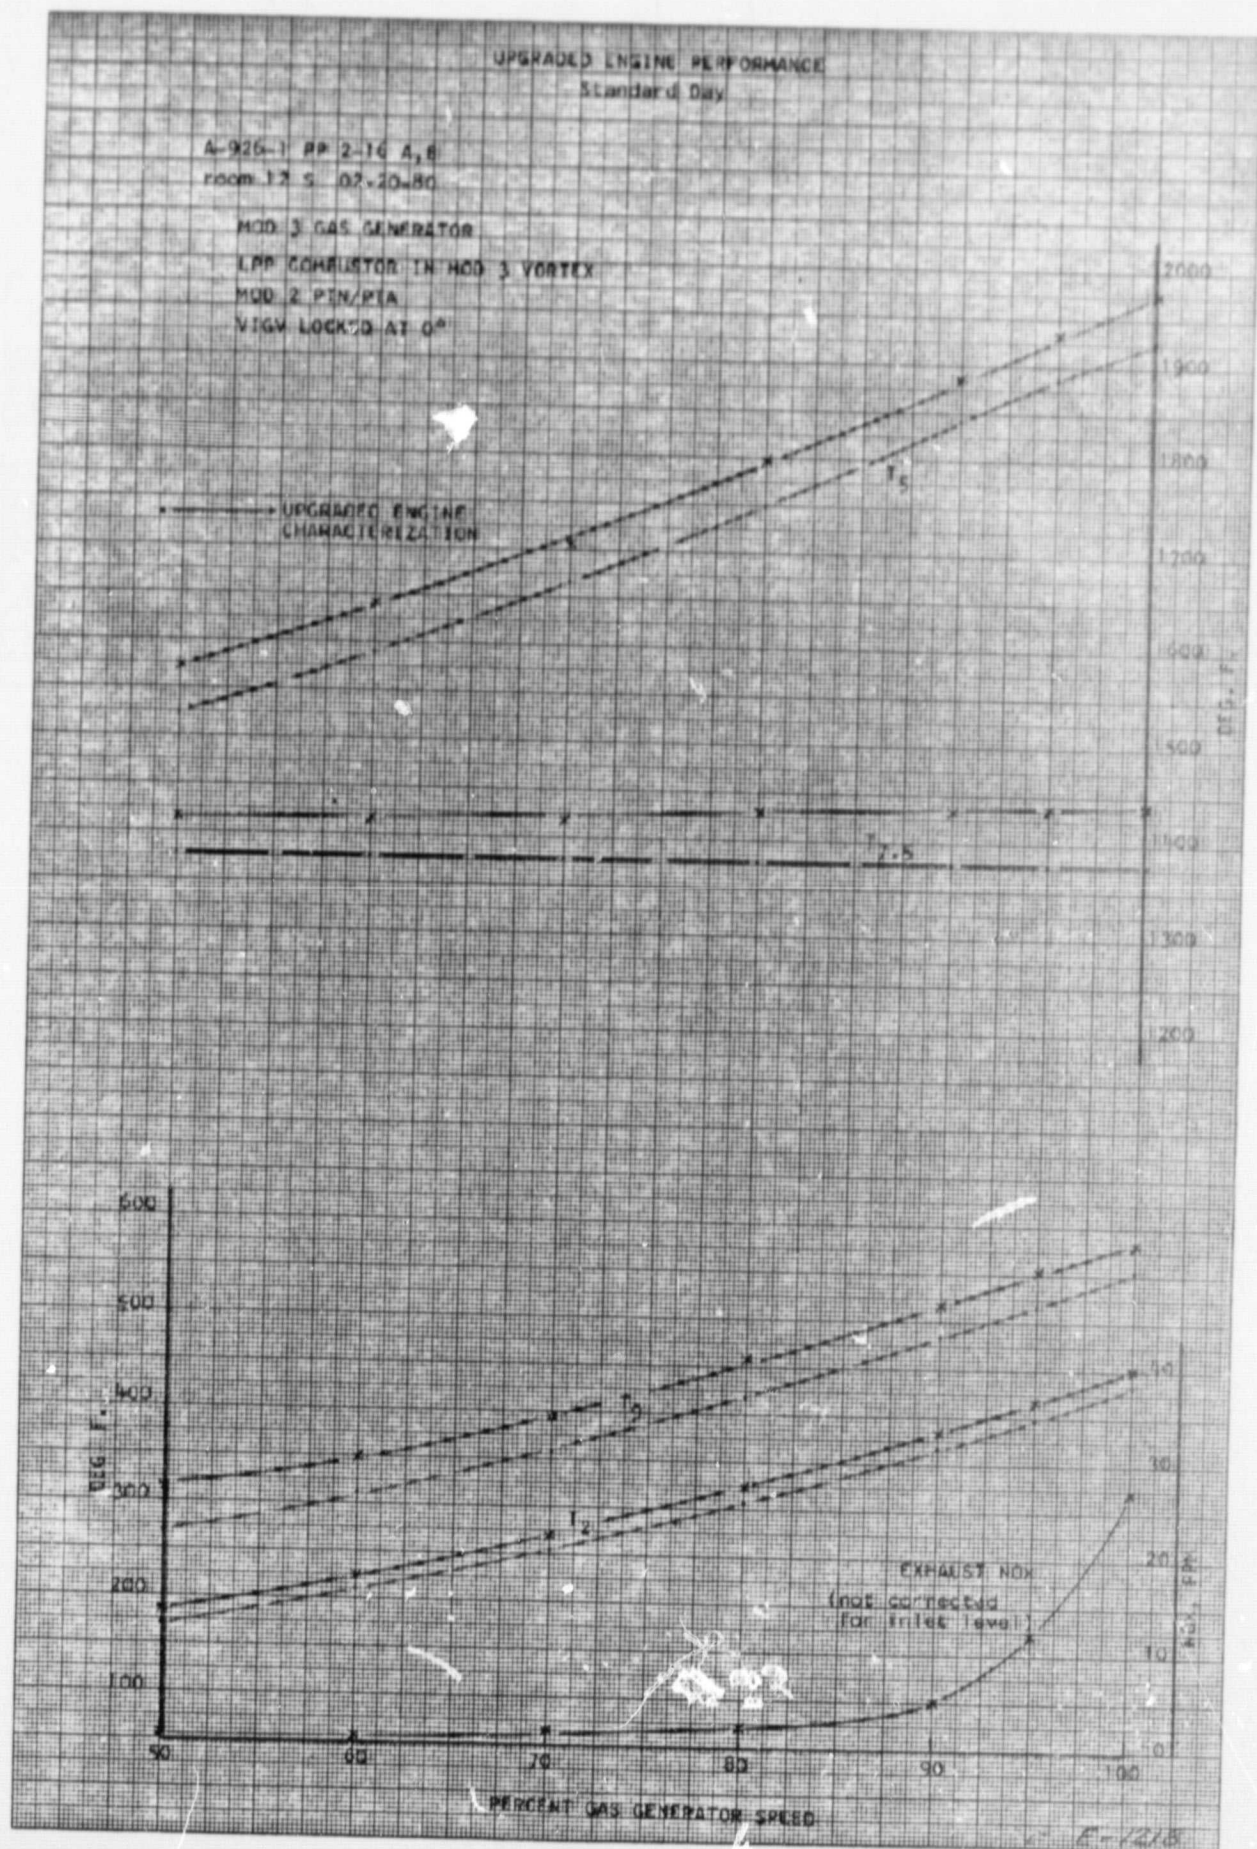
FIGURE 11

A combustor problem early in the test period was resolved by increasing burner dilution area by 20%; final NOx emissions values are shown on Figure 11. A speed stability problem above 80% Ngg was traced to a design deficiency in the ECU. Documentation of corrective action is shown in Appendix C (Failure Report 82).

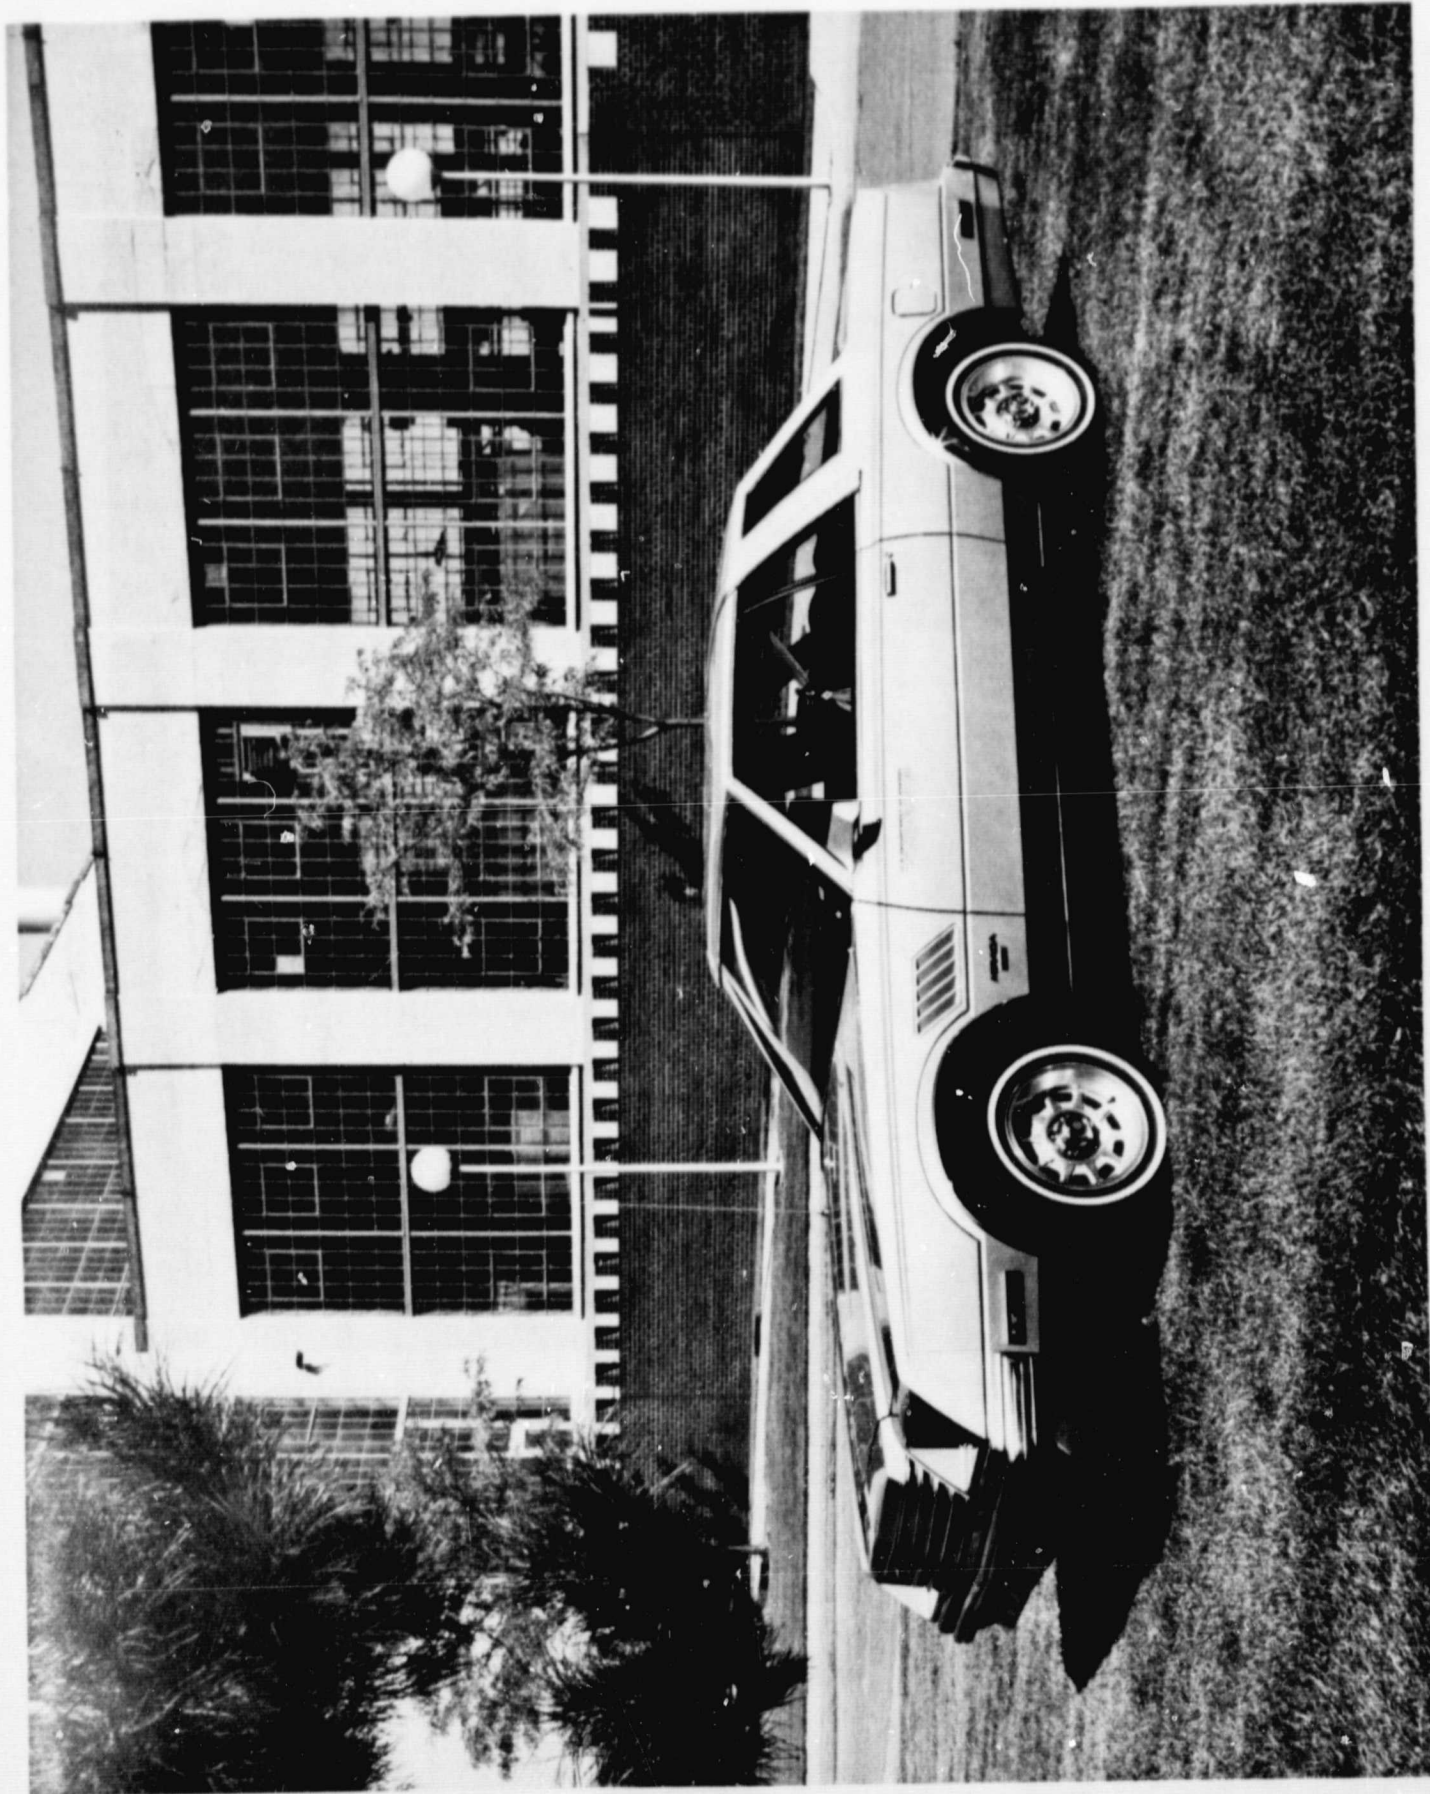
FIGURE 18a

Vehicle U-4 and the engine installation are shown in Figures 18a and 18b.

VEHICLE U4, 1980 DODGE MIRADA

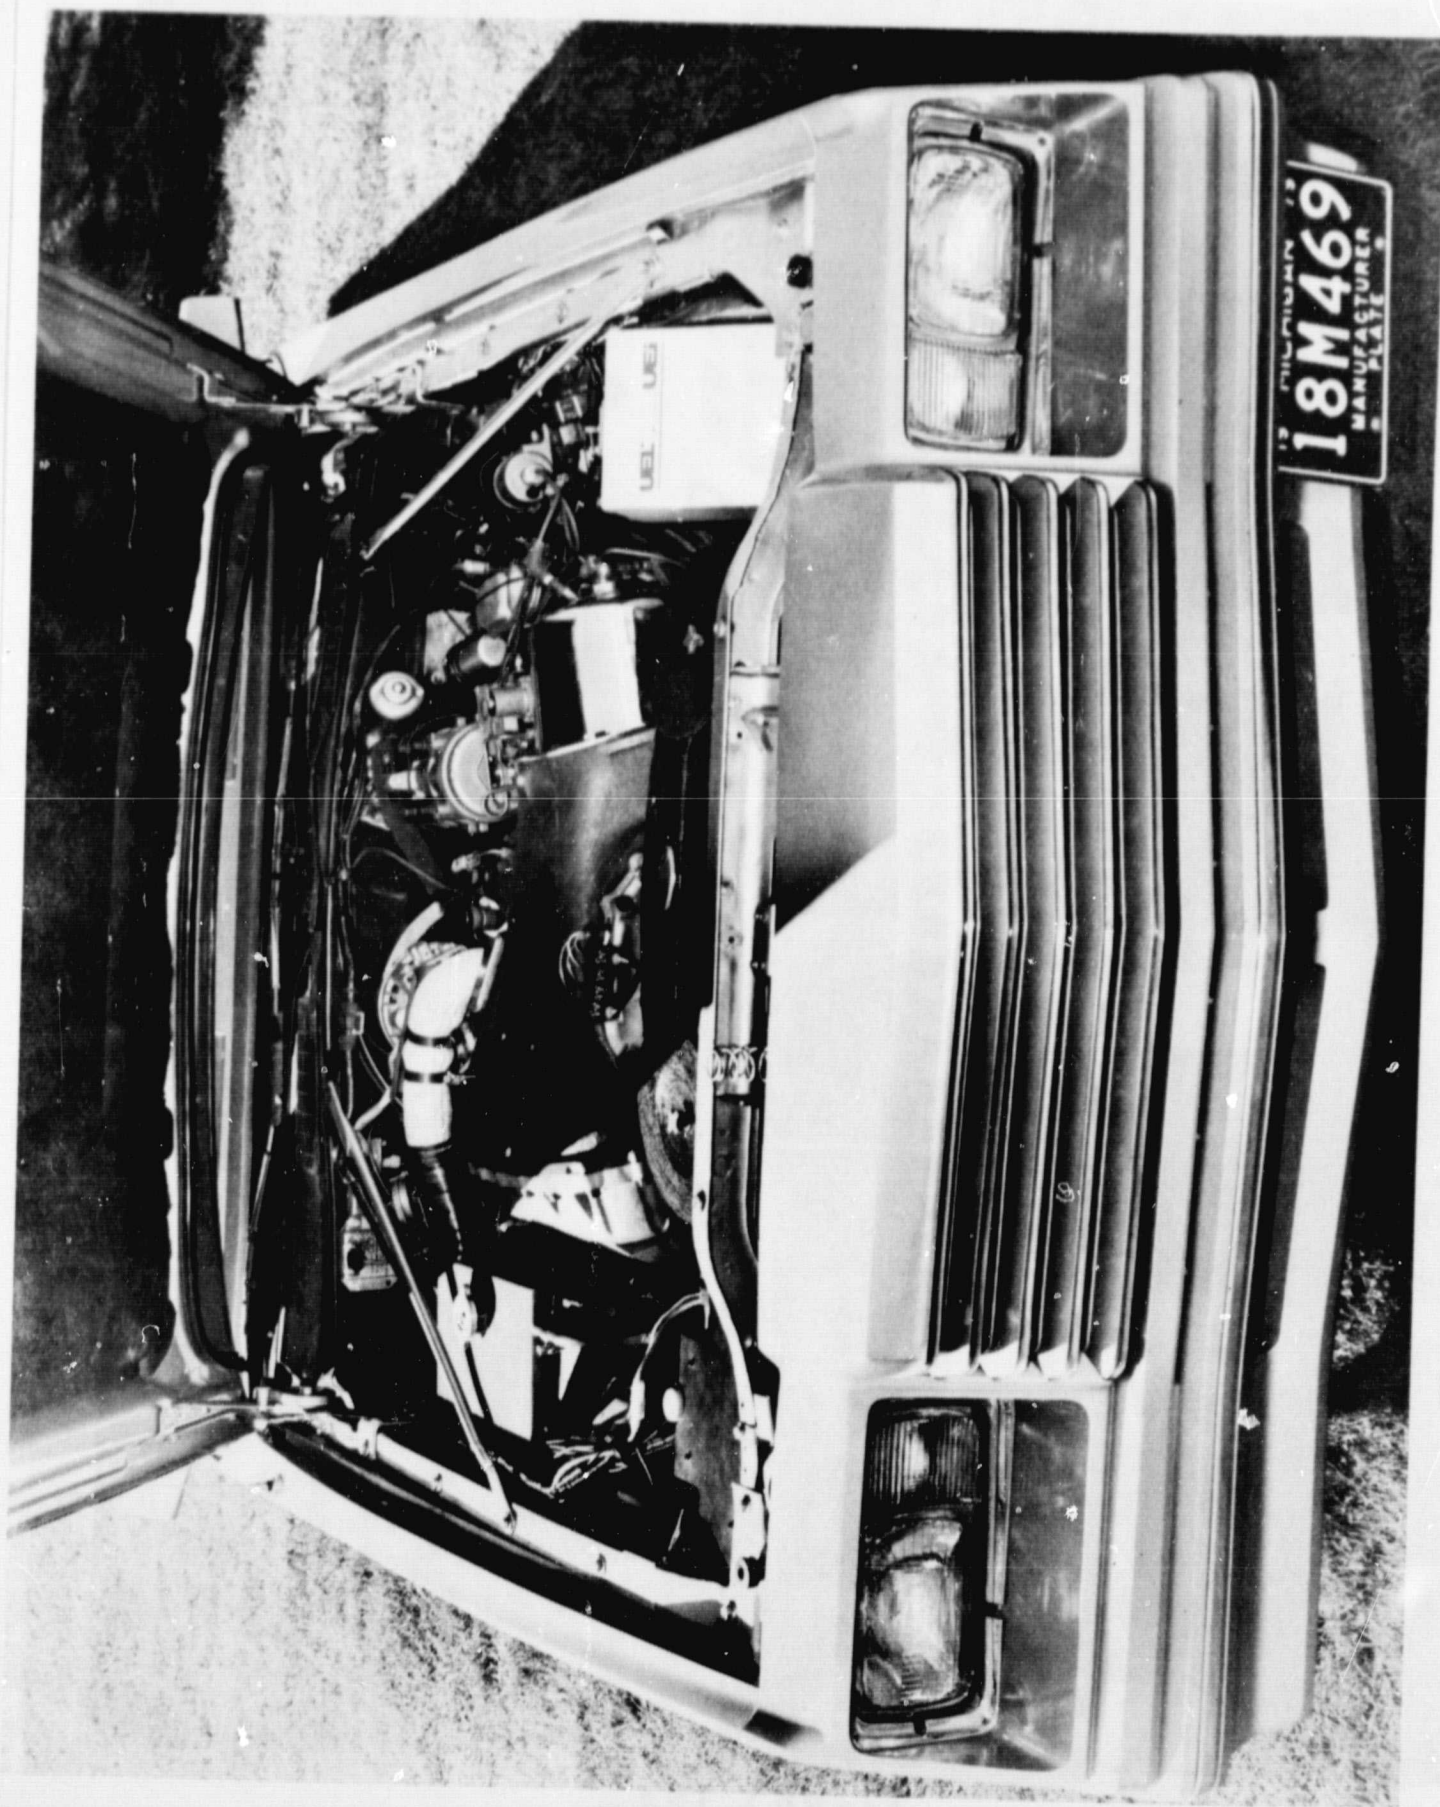
FIGURE 18b

ENGINE INSTALLATION - VEHICLE U4, 1980 DODGE MIRADA

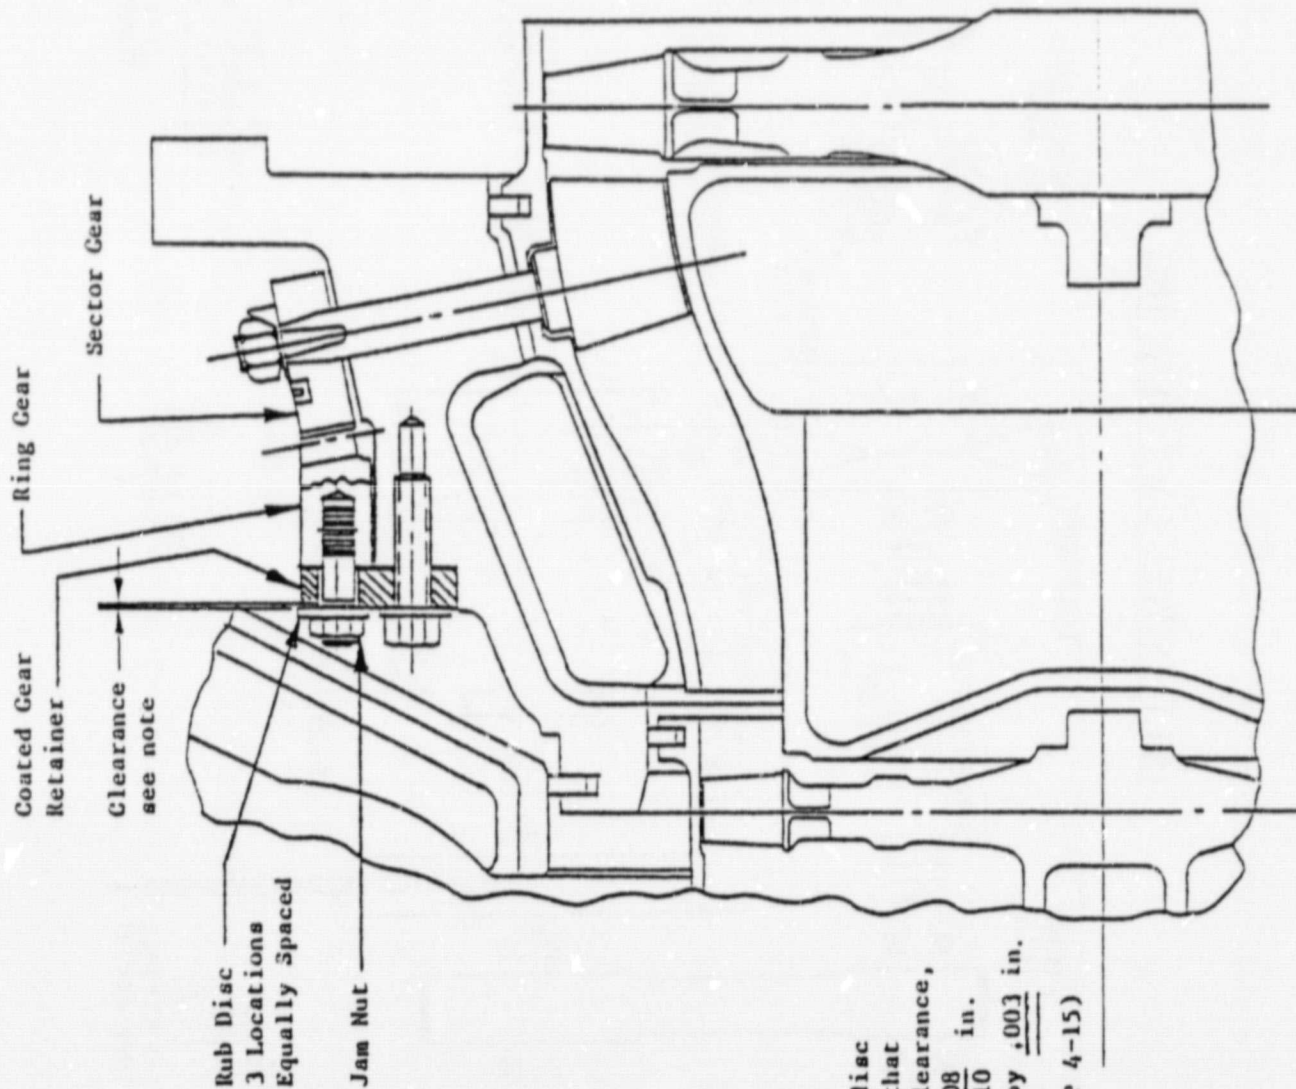
FIGURE 20

NOTE: Adjust rub disc
jam nut so that
ring gear clearance,
nominally $\frac{.008}{.010}$ in.
is reduced by $\frac{.003}{.010}$ in.
(PTN -3, PP 4-15)

POWER TURBINE NOZZLE VANE MECHANISM MODIFICATION
WITH 3 RUB DISCS INSTALLED ON RING GEAR

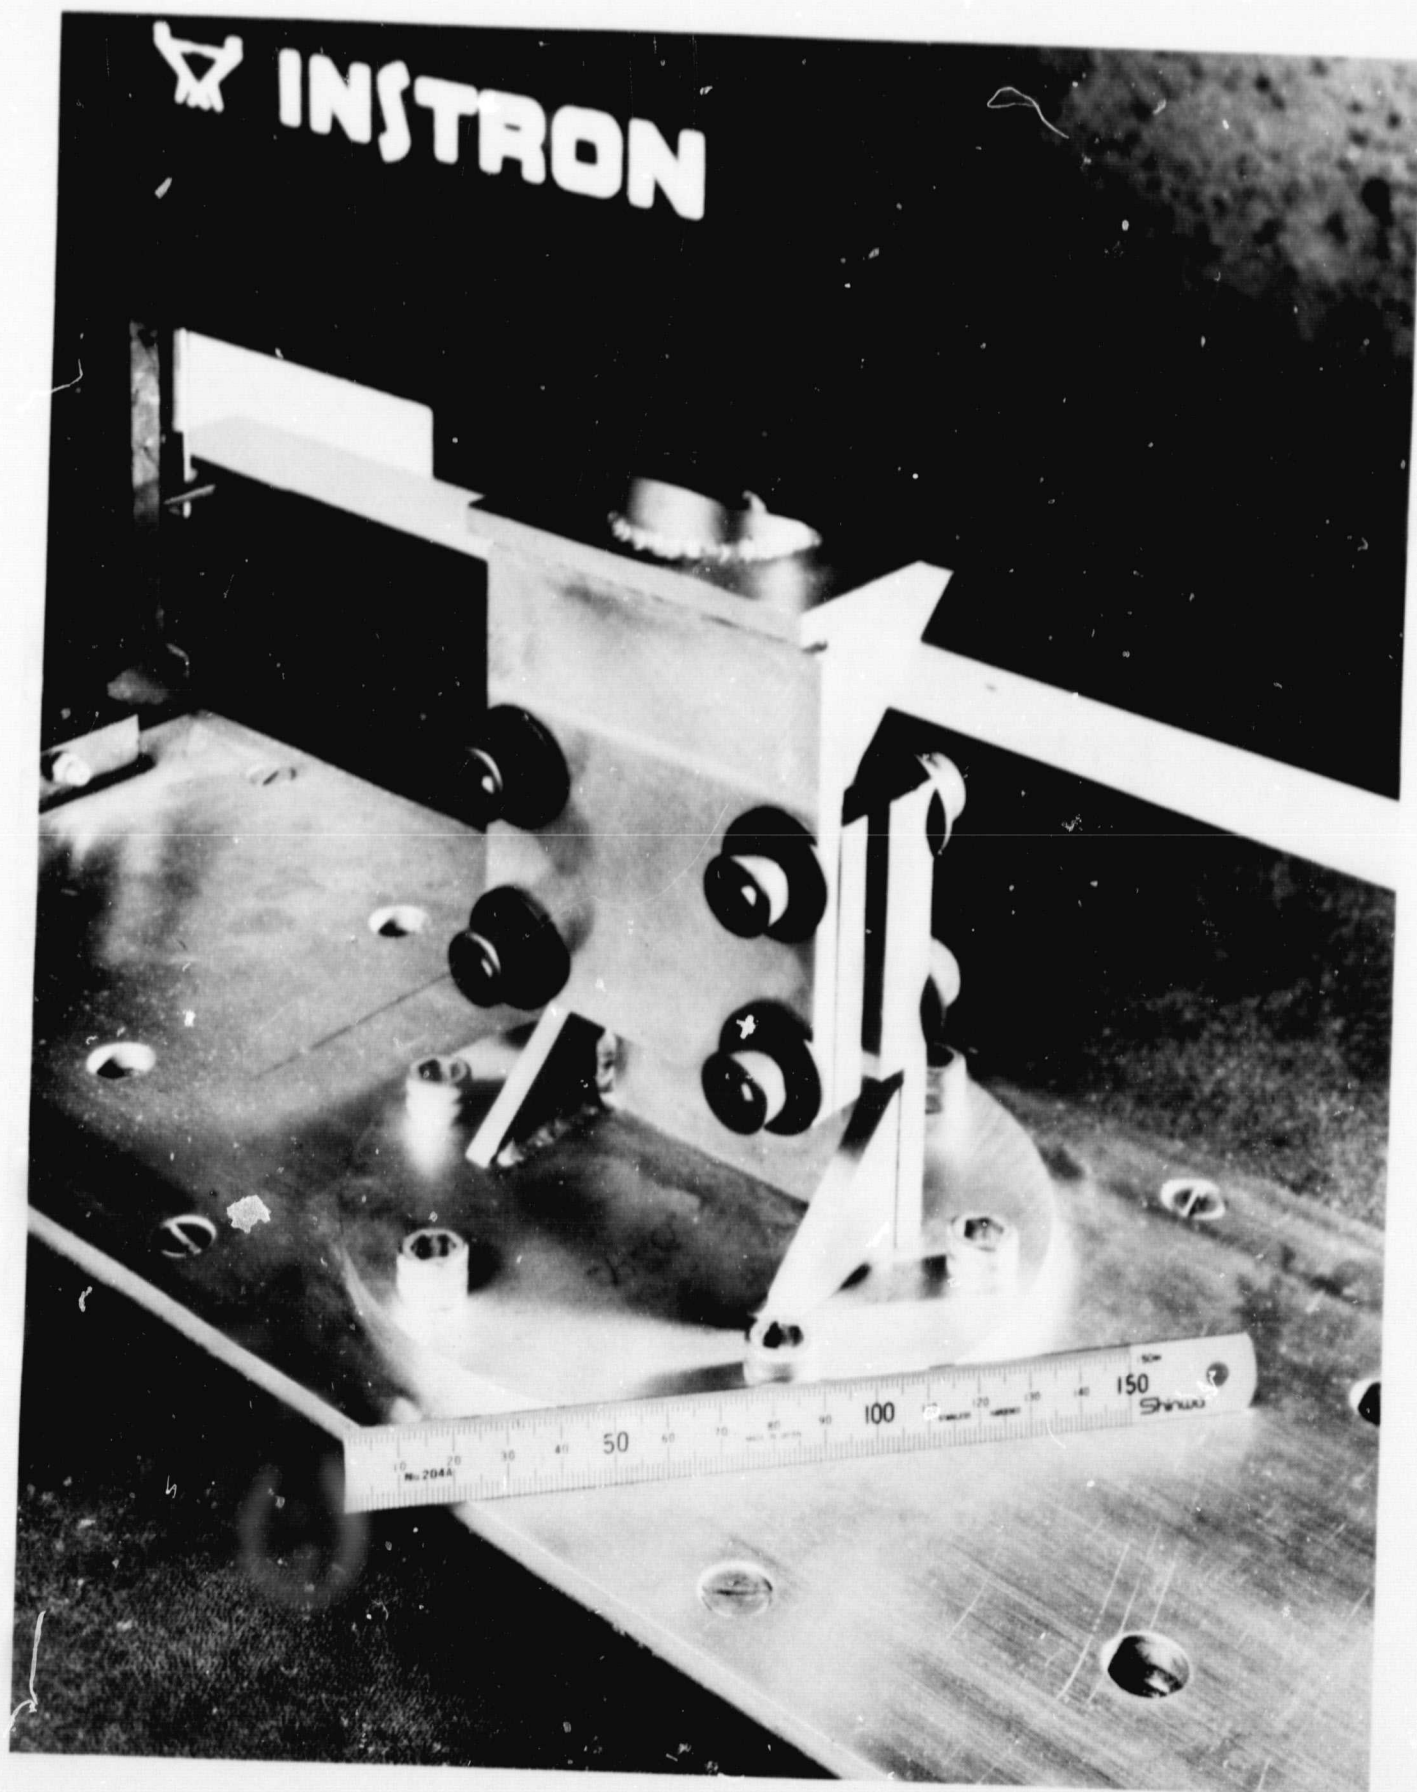
FIGURE 24

To aid in checking properties of new shipments of elastomer, and to investigate the elastomer's strength at projected operating temperatures, a shear test fixture was designed and fabricated. Figures 24a and 24b show this fixture as installed in the Instron test machine. Also shown is a typical shear specimen before and after test (see Figure 25). The specimens are prepared under conditions identical to those used for installing ring gears, with the same elastomer thickness (nominally 7 mm.), and with a minimum cross-sectional area of one square inch. In an effort to force the samples to fail in shear (as found at NASA), they were prepared with generous fillet radii on all edges. However, all the room temperature samples failed by peeling rather than in shear, with an average shear load at failure of 330 psi. This compares to the A926 elastomer design shear load of 3.5 psi, implying a room temperature safety factor of about 95 - clearly not a marginal design.

ELASTOMER SAMPLE SHEAR TEST FIXTURE

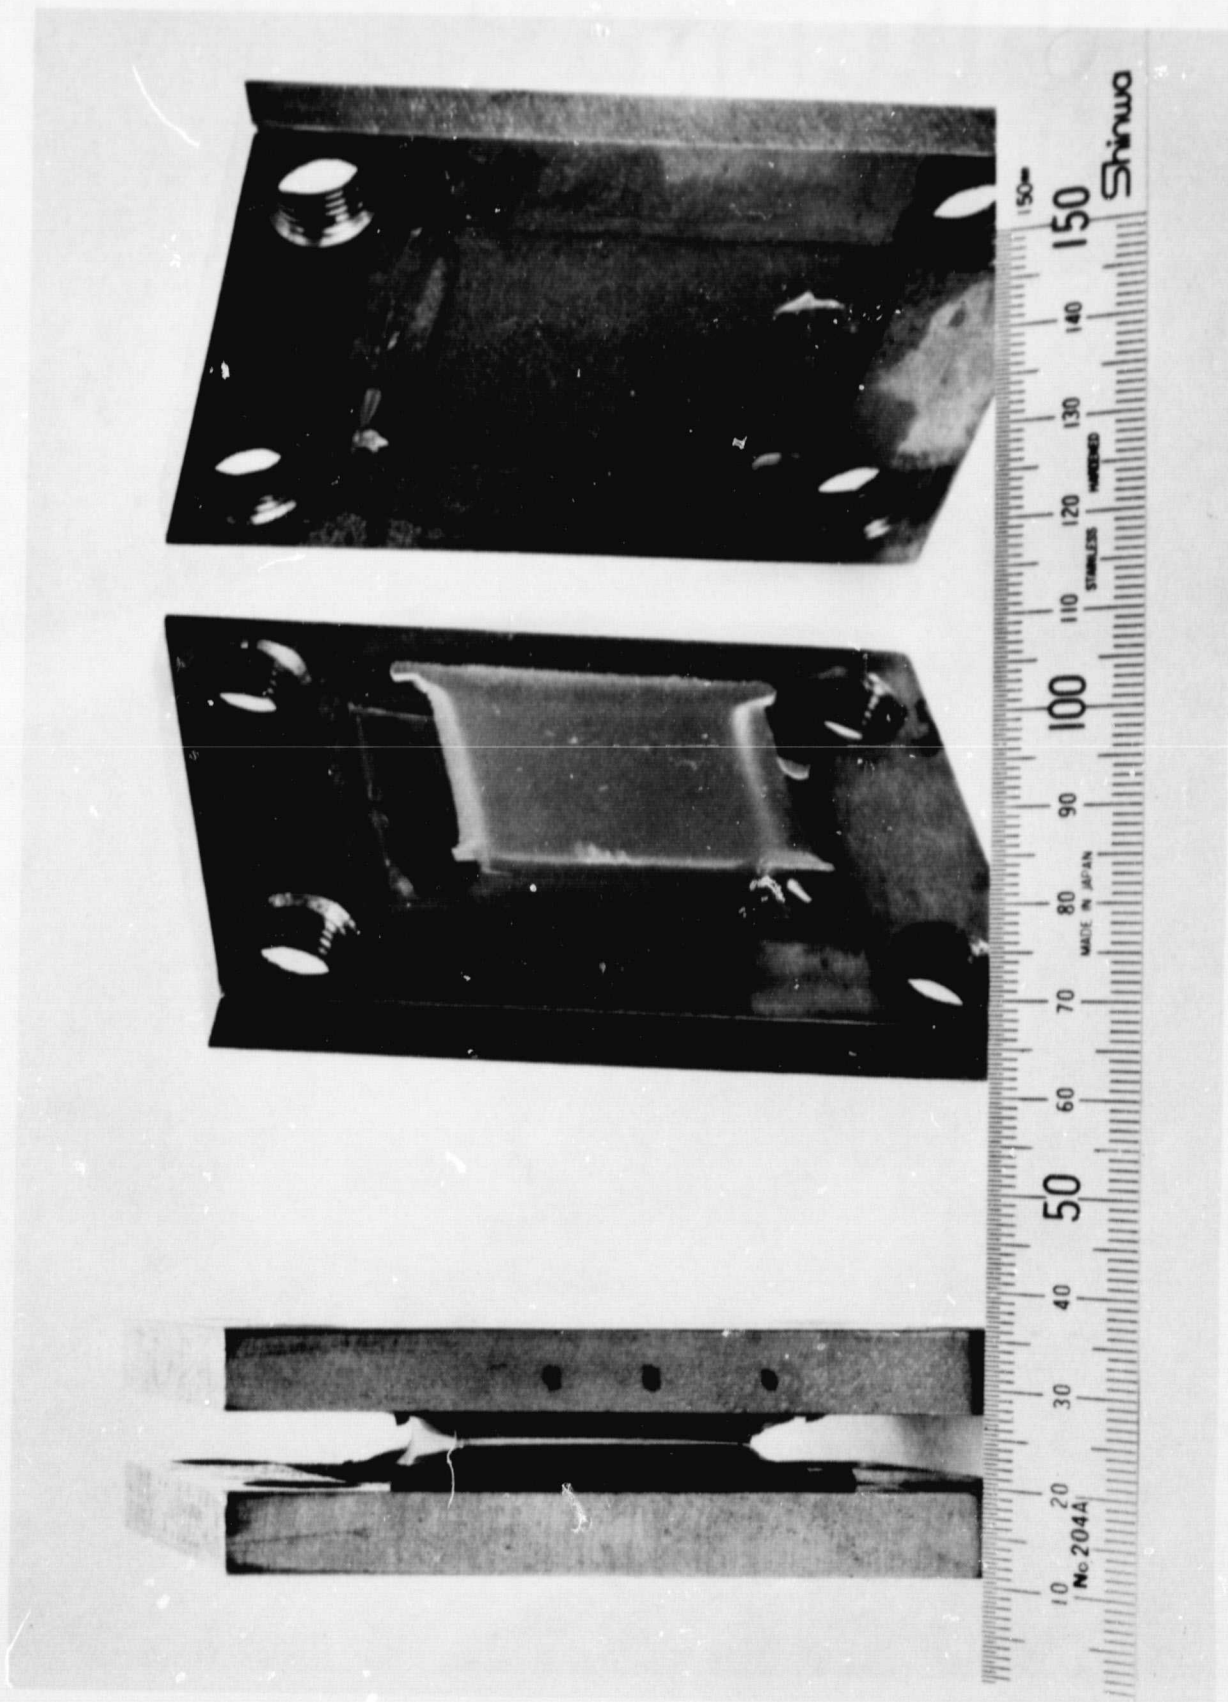
FIGURE 25

ELASTOMER SAMPLES BEFORE AND AFTER TEST

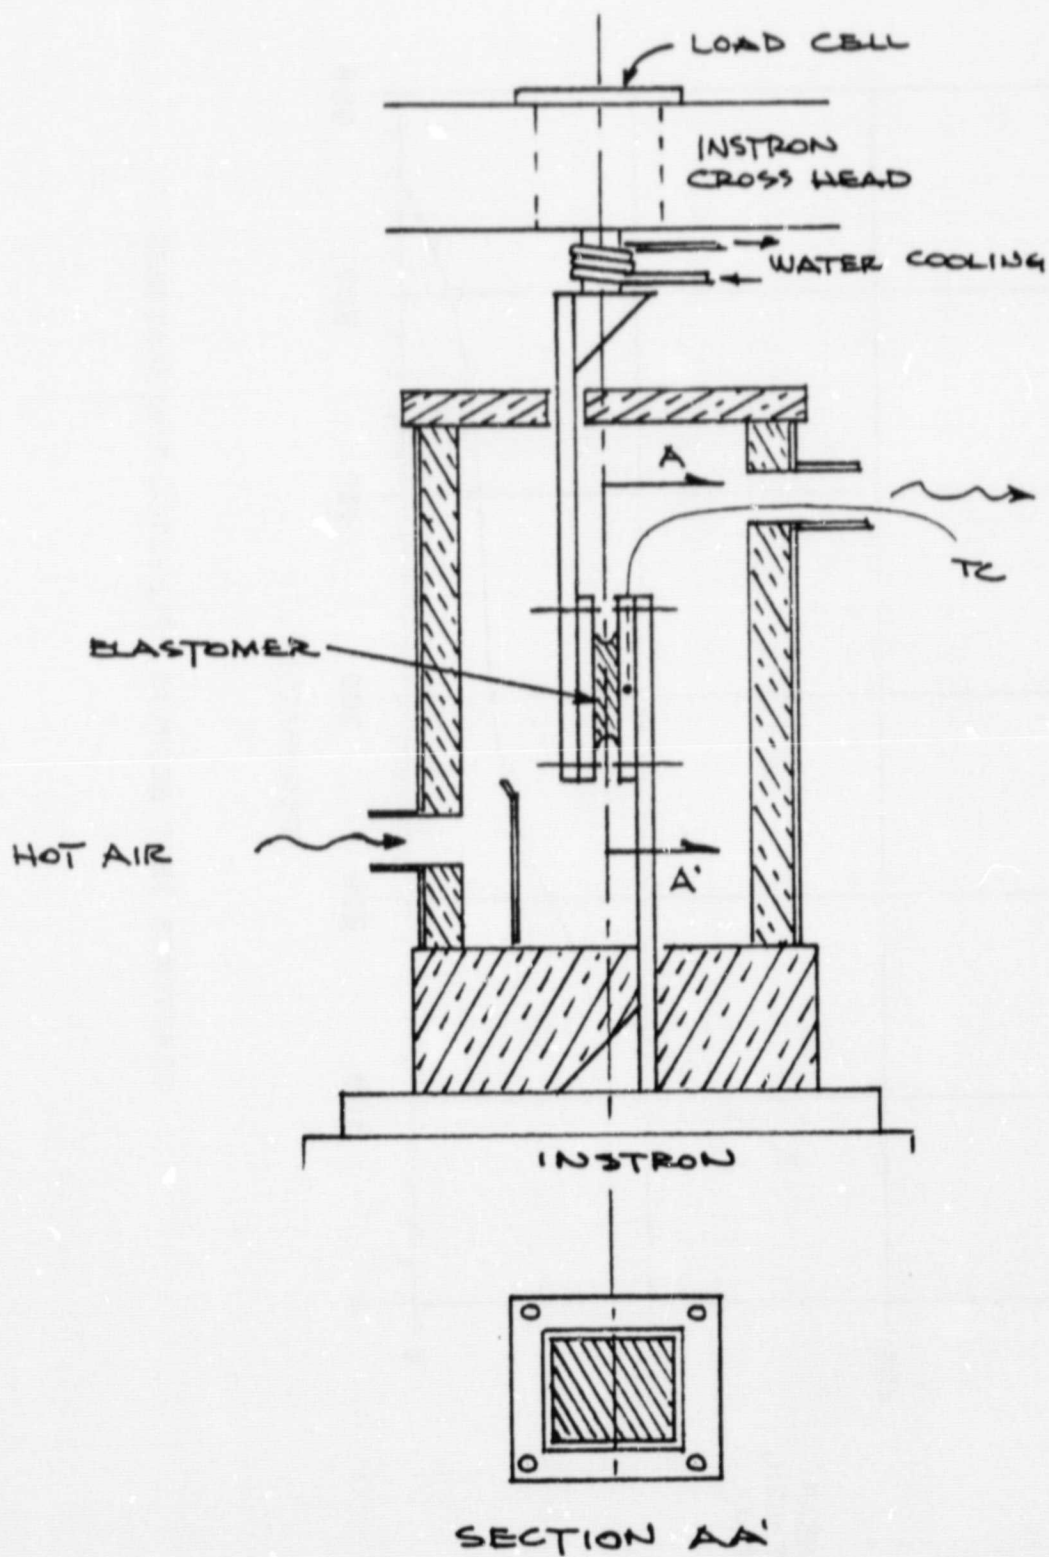
FIGURE 26

The fixture was then modified to allow shear testing at elevated temperatures, as shown in Figure 26. Preliminary test results, shown on Figure 27, indicate a substantial drop in material properties in the 300-500°F range, but the design safety factor is still 14 at 500°F. It was noted that specimens tested at 500°F and above failed in the shear mode (as compared to the peel mode for the room temperature samples), which matches the failure mode observed at NASA. Samples between 300 and 500°F showed evidence of both failure modes. Testing of Sylgard 186 and candidate replacement materials is continuing with emphasis on the critical 400-600°F range.

ELASTOMER SHEAR TEST FIXTURE
ELEVATED TEMPERATURES
